# Your Inspection Report

123 MD Inspect Plus Inc  
Building Inspection, QC

**INSPECTION DATE:**  
Tuesday, August 24, 2010

Report No. 1198

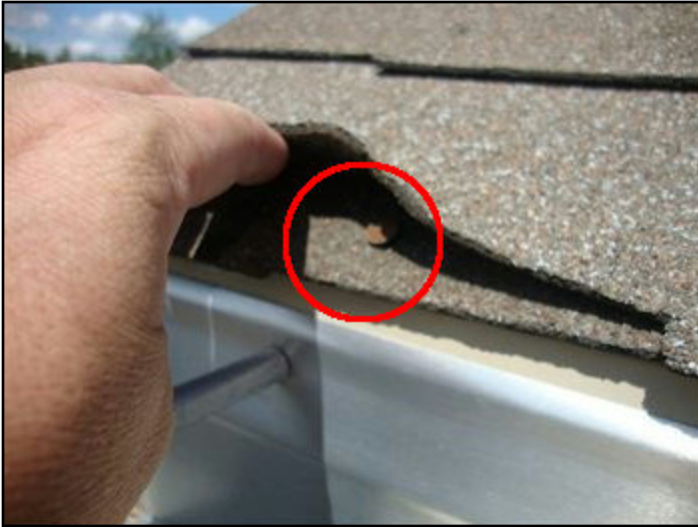
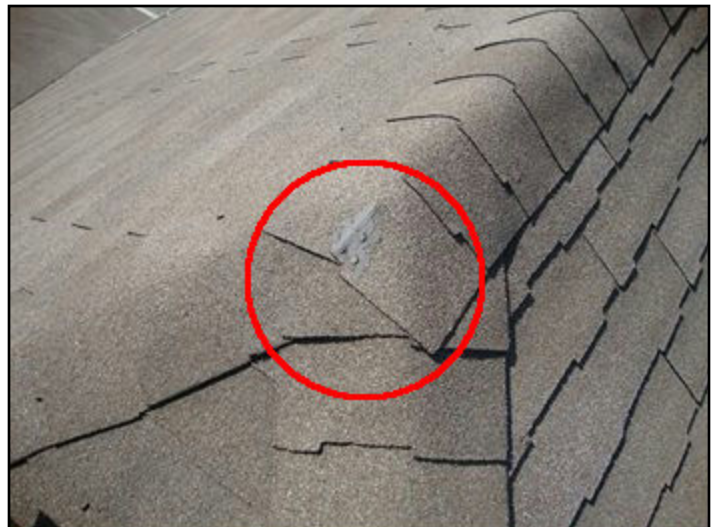
**2. Condition:** • [Exposed fasteners](#)

*Exposed Nail Head On Edge*

*Exposed Nail Heads*

*Exposed Nail Heads.*

**Task:** Repair

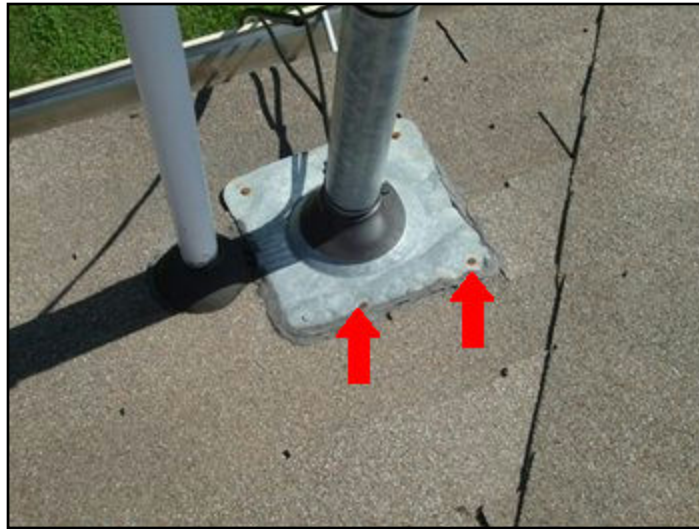
### **3. Condition:** • [Top of flashing exposed or bottom buried](#)

The upper part of the flashing should be under the shingles. Make sure the joint stays properly sealed. The nail heads should also be sealed with a roofing tar.

*Flashing Installed Wrong.*

**Task:** Monitor

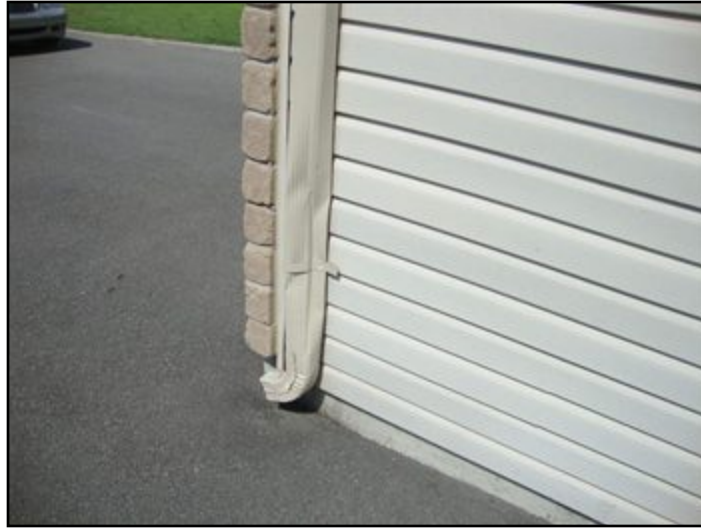
4. Condition: • [Damage](#)

*Damaged Downspout.*

Task: Repair

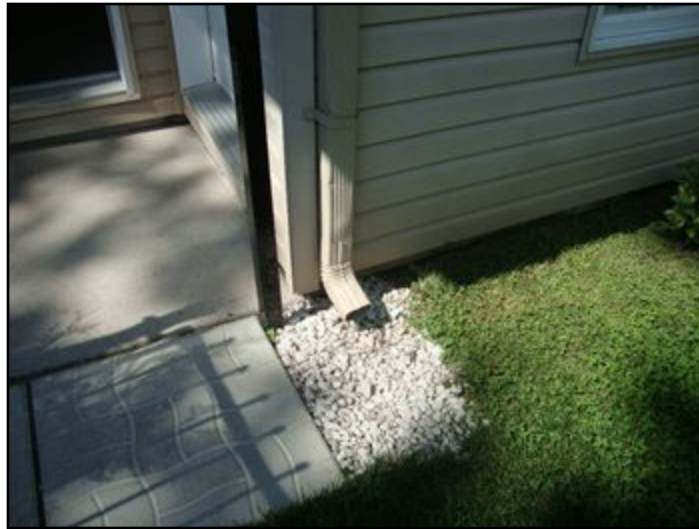
**5. Condition:** • [Downspouts end too close to building](#)

**Implication(s):** Chance of water damage to contents, finishes and/or structure

*Extend Away From The Building.*

**Task:** Improve

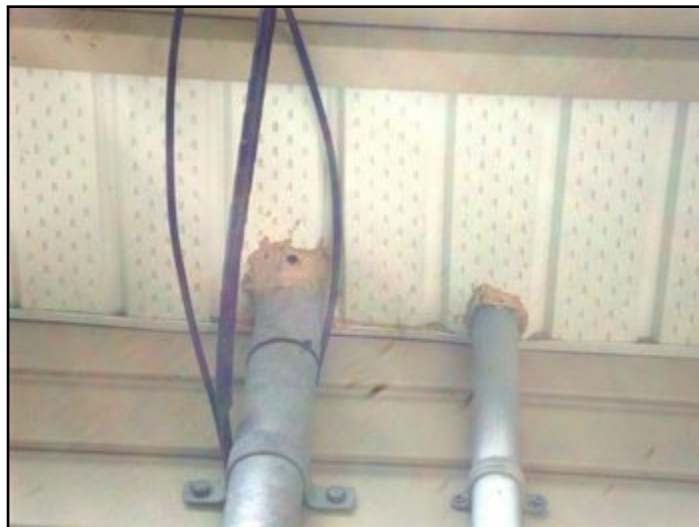
### **6. Condition:** • [Damage](#)

*Caulking Repairs Required*

**Task:** Repair

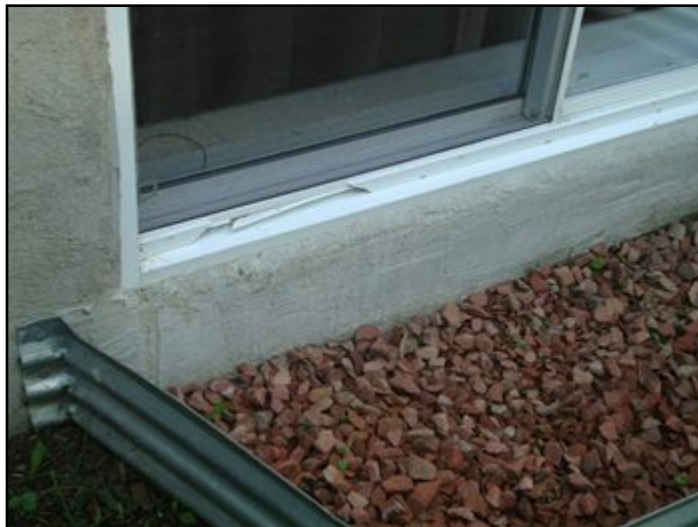
**7. Condition:** • The damaged part is only holding the screen.

*Damaged Window Frame.*

**Task:** Replace

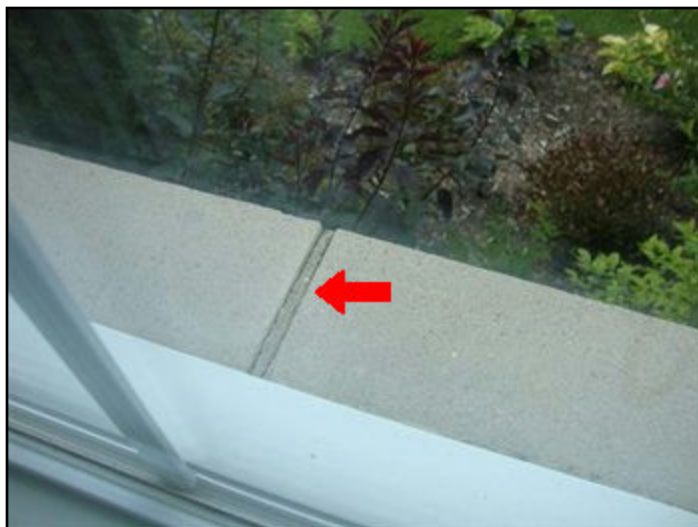
**8. Condition:** • [Sill deteriorated](#)

*Repair Joint In Window Sills.*

The mortar joints in the window sills should be repaired with an outdoor caulking designed for use with concrete/brick (one brand name is SikaFlex). Chip away about 1/4" of mortar and fill the joint with the caulking.

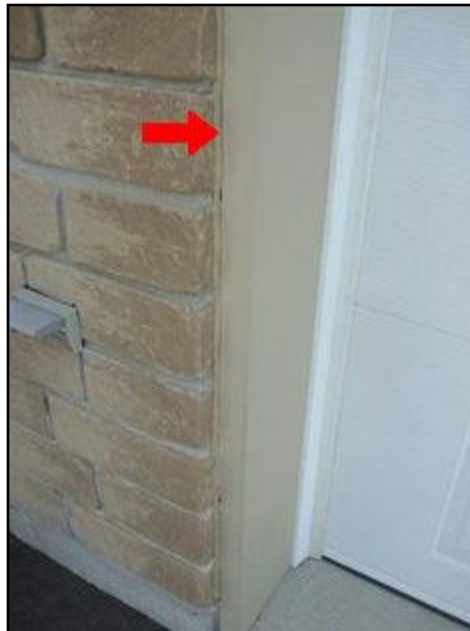
**9. Condition:** • [Caulking missing, deteriorated or loose](#)

*Caulking Repairs Required.*

**Task:** Repair or replace

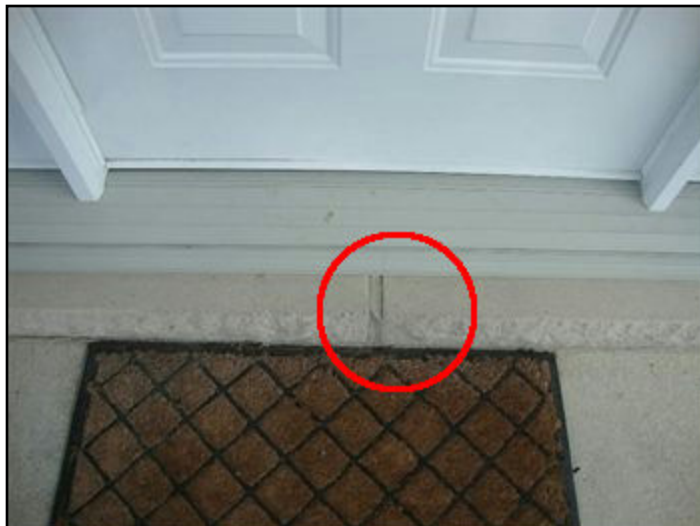
**10. Condition:** • [Sill deteriorated](#)

*Fix Joint In Door Sill*

The mortar joints in the patio door sills should be repaired with an outdoor caulking designed for use with concrete/brick (one brand name is SikaFlex). Chip away about 1/4" of mortar and fill the joint with the caulking.

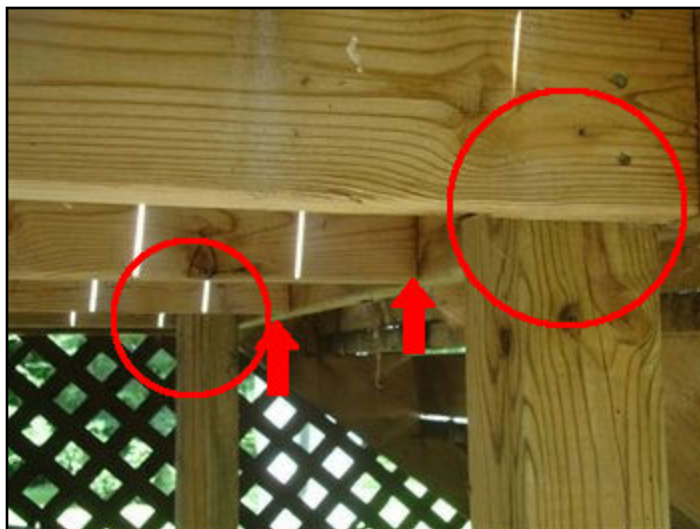
**11. Condition:** • Current deck construction includes a variety of brackets to join the different members of the deck structure together. Even older decks should be retrofitted to use these brackets. For information on brackets, go to <http://www.safestronghome.com/deck/index.asp>

*Brackets Could Be Added To Deck.*

**Task:** Provide

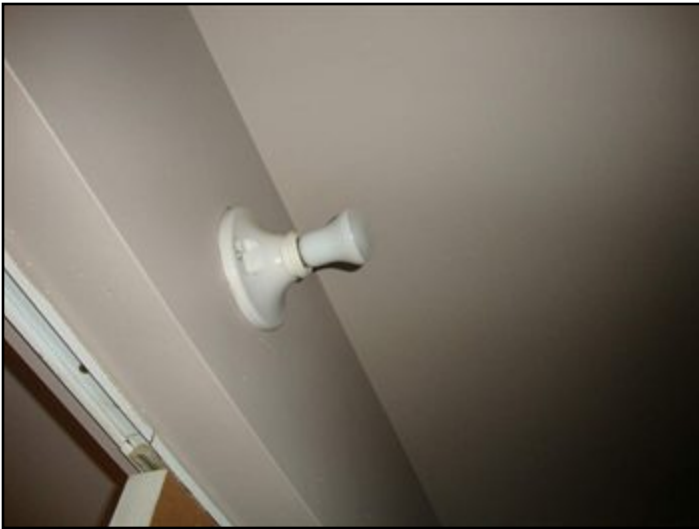
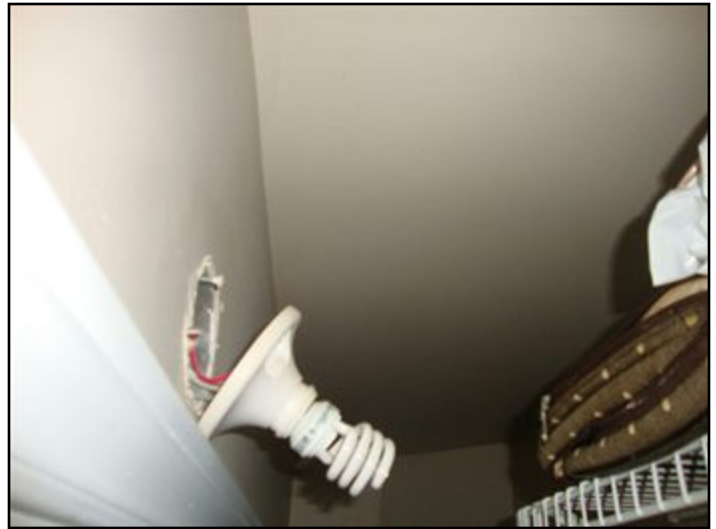
**14. Condition:** • [Improper closet lighting](#)

**Implication(s):** Fire hazard

*Exposed Bulbs Not Allowed In Closets.*

*Fixture Not Properly Secured.*

**Task:** Repair or replace

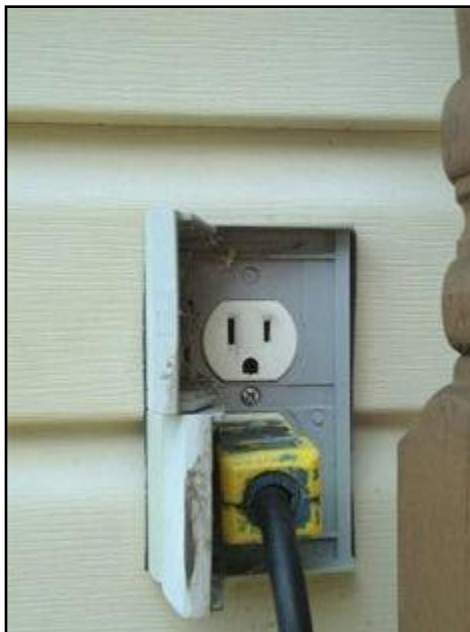
**16. Condition:** • [Ground Fault Interrupter \(GFI\) needed](#)

*Outdoor Plugs Should Be GFCI Protected.*

**Task:** Replace

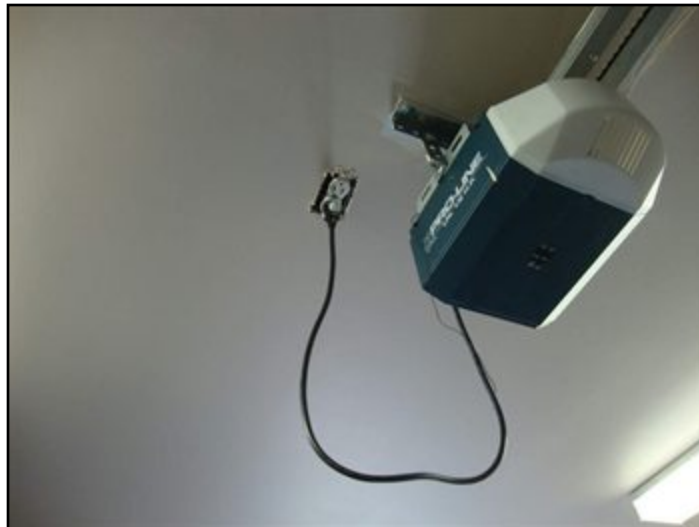
**17. Condition:** • [Missing](#)

*Missing Cover Plate.*

**Task:** Provide

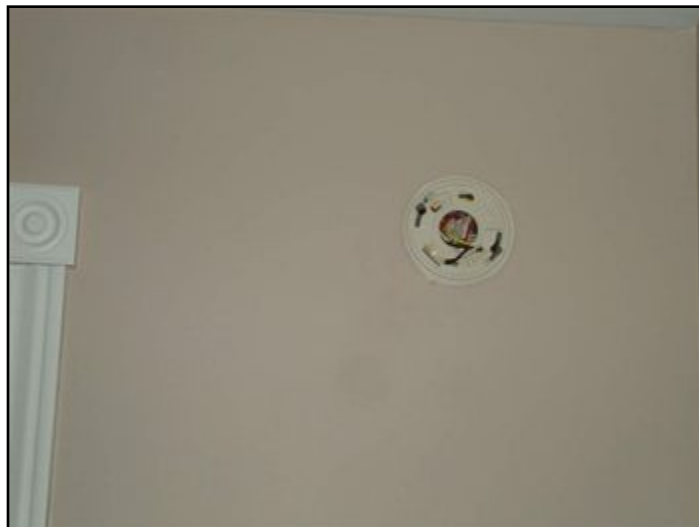
**18. Condition:** • [Inoperative](#)

**Implication(s):** Fire hazard

*Smoke Detector Missing*

**Task:** Provide

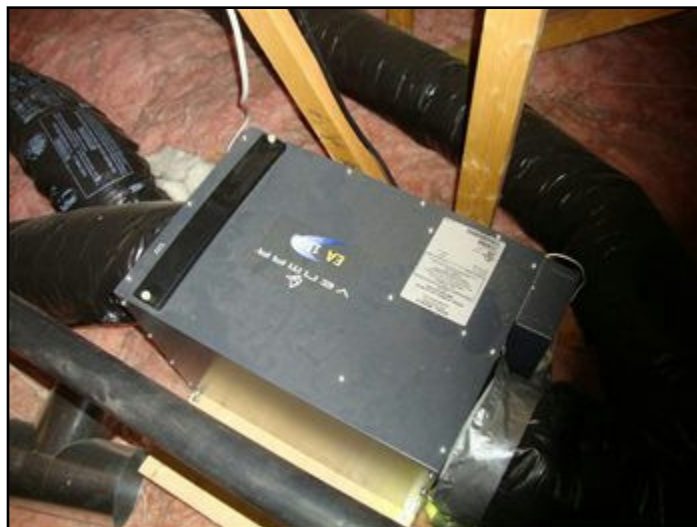
**19. Condition:** • The filters and exchanger core should be cleaned as per the manufacturer's instruction (normally every 6 months).

*HRV In Attic*

**Task:** Clean

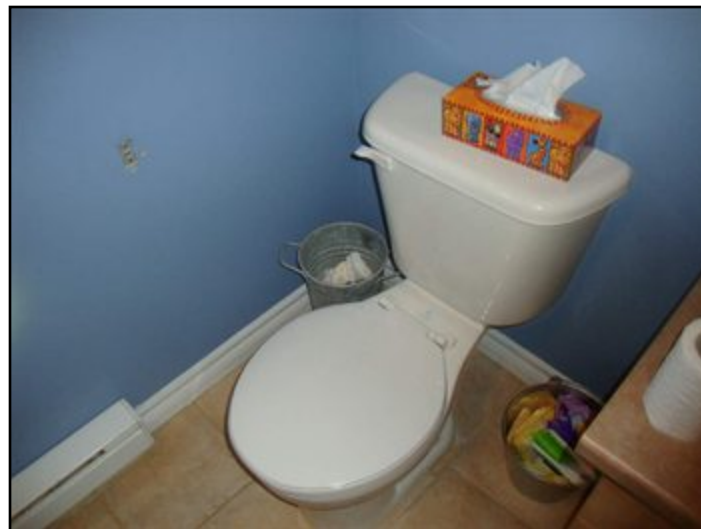
**22. Condition:** • [Loose](#)

**Implication(s):** Chance of water damage to contents, finishes and/or structure | Sewage entering the house

*Loose Toilet.*

**Task:** Repair

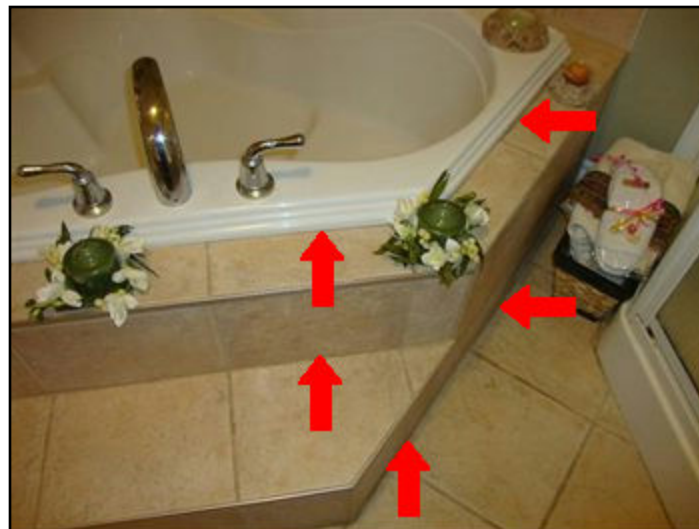
**23. Condition:** • [Caulking loose, missing or deteriorated](#)

Caulking Required.

**Task:** Repair or replace

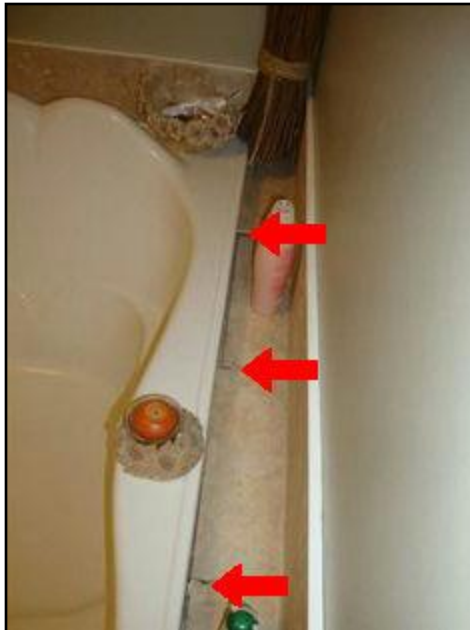
**24. Condition:** • [Grout loose, missing or deteriorated](#)

*Missing Grout.*

The missing grout could be replaced with some bathroom caulking. Mapei now make a caulking that matches the grout colors.

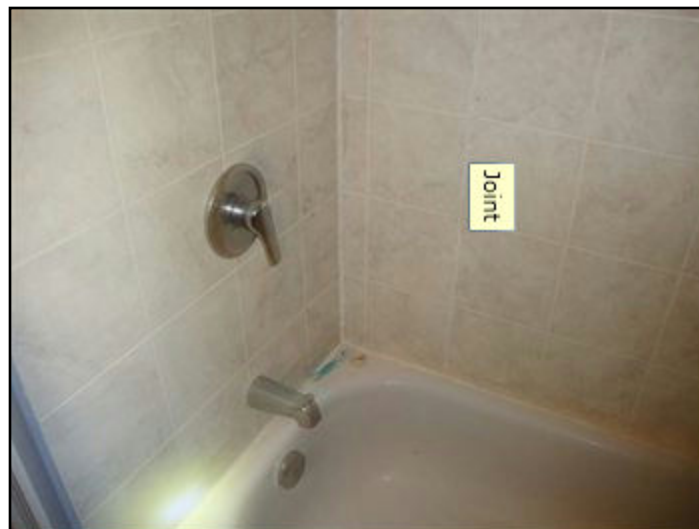
**25. Condition:** • [Caulking loose, missing or deteriorated](#)

*Shower Walls Are Not Tiles.*

**Task:** Monitor

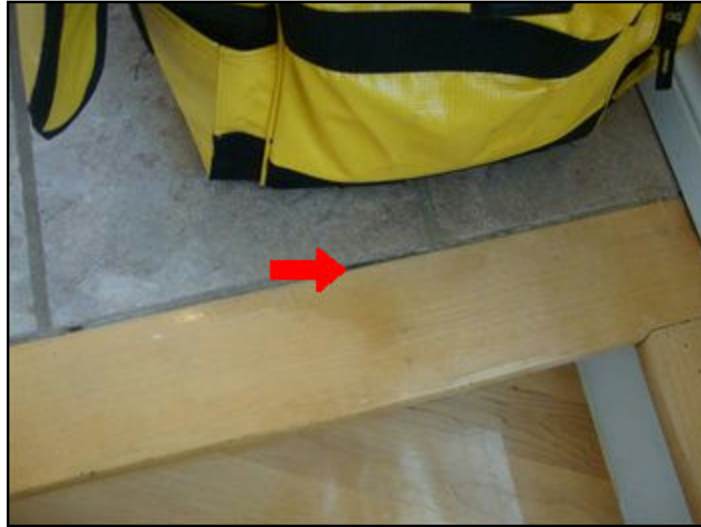
26. Condition: • [Grout loose](#)

*Seal Joint With Caulking*

Mapei sell a caulking that should match the exiting grout lines. If a matching color can't be found, a clear indoor caulking can be used.

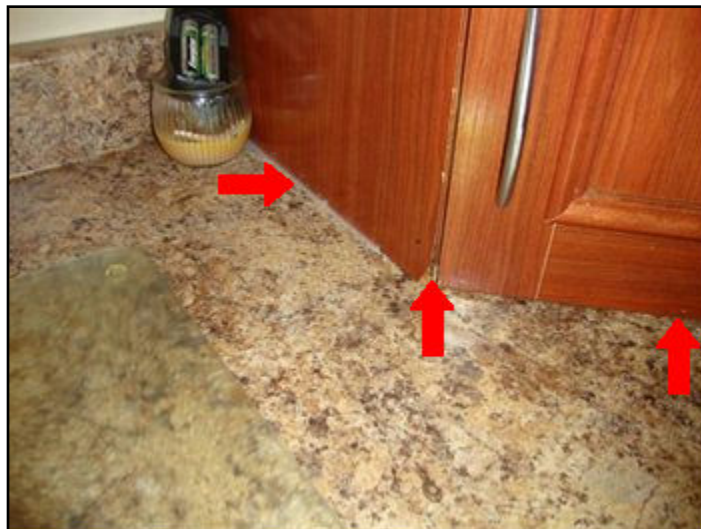
**27. Condition:** • [Water damage](#)

*Seal Joints With Caulking.*

**Task:** Cover

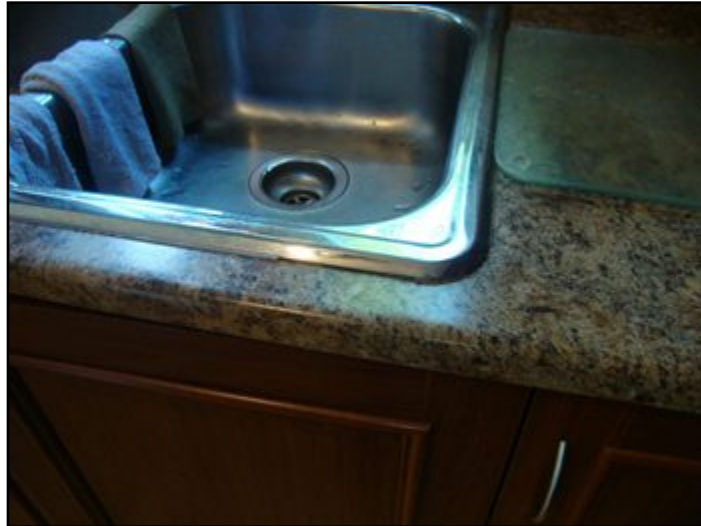
**28. Condition:** • Caulking missing/damaged between countertop and backsplash/wall/sink/cabinet.

*Caulking Repairs Around Sink.*

**Task:** Repair or replace

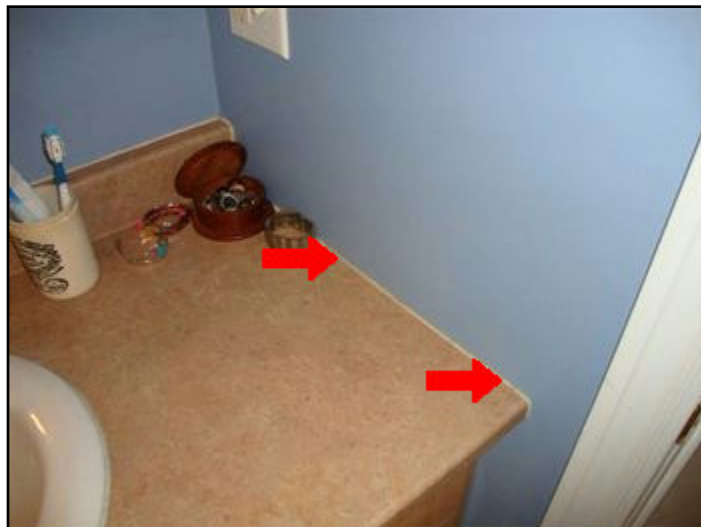
**29. Condition:** • Caulking missing/damaged between countertop and backsplash/wall/sink/cabinet.

*Caulking Repairs Required.*

**Task:** Repair or replace

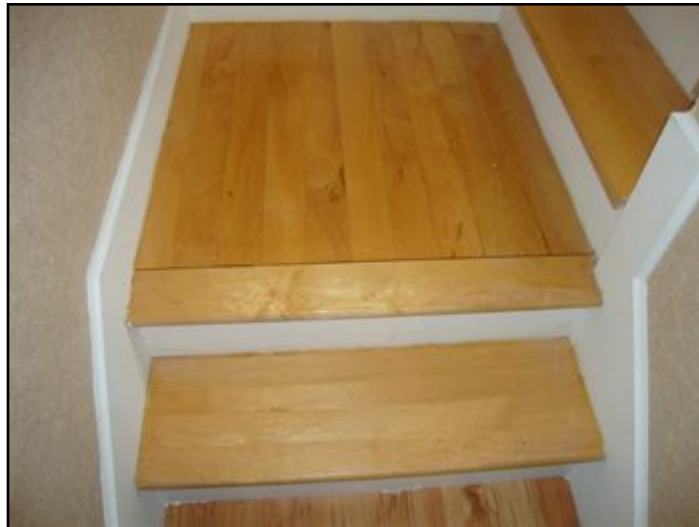
**31. Condition:** • [Loose](#)

*Stair Nosing Has Moved.*

**Task:** Repair

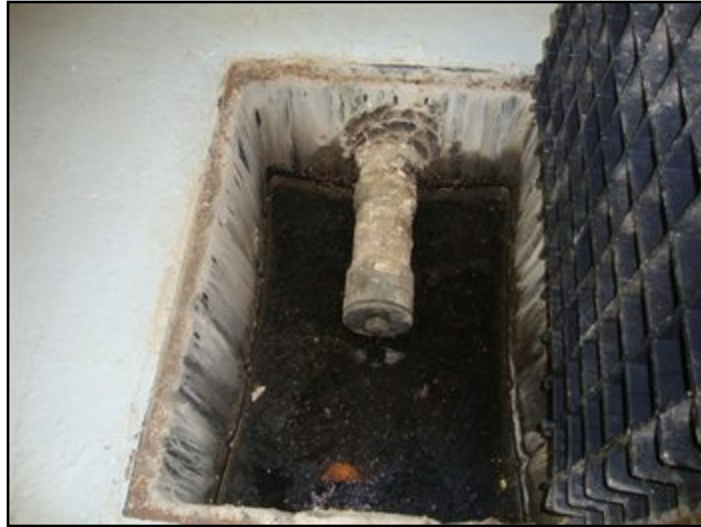
**33. Condition:** • The floor drain in the garage should be cleaned regularly.

Clean Floor Drain.

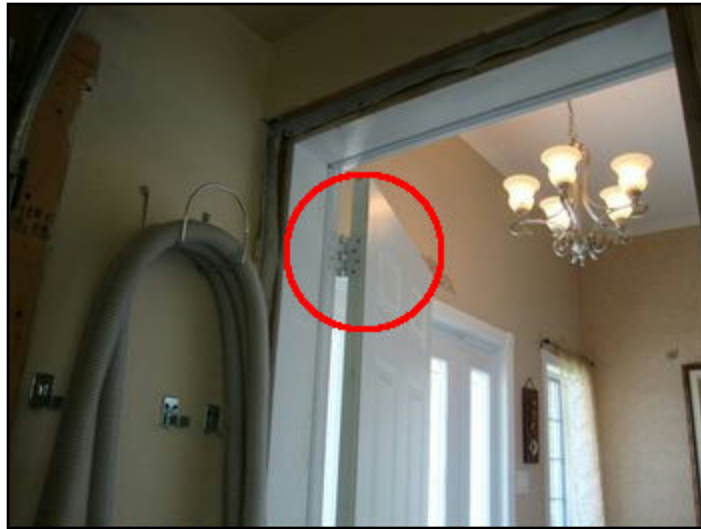
34. Condition: • [No self closer](#)

Implication(s): Hazardous combustion products entering home

Install Self-Closing Hinge.

Task: Repair

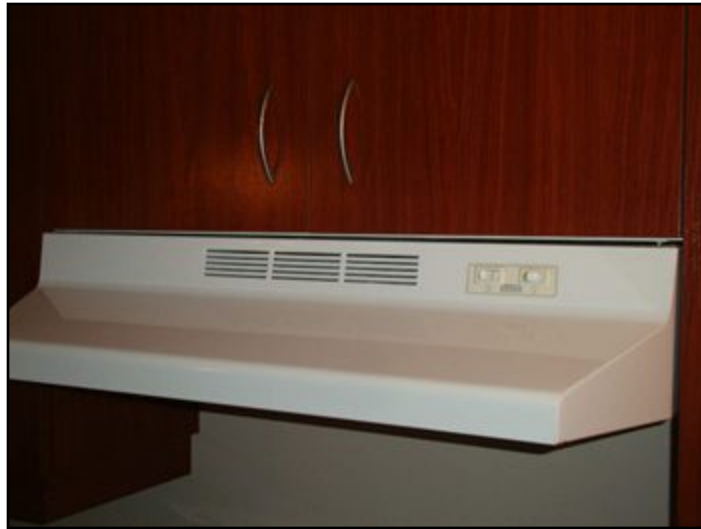
**35. Condition:** • Not vented to exterior

*Fan Does Not Vent Outside.*

**Task:** Repair
